# Analysis of Strain Gage Reliability in F-100 Jet Engine Testing at NASA Lewis Research Center

Ray Holanda  
*Lewis Research Center*  
*Cleveland, Ohio*

March 1983

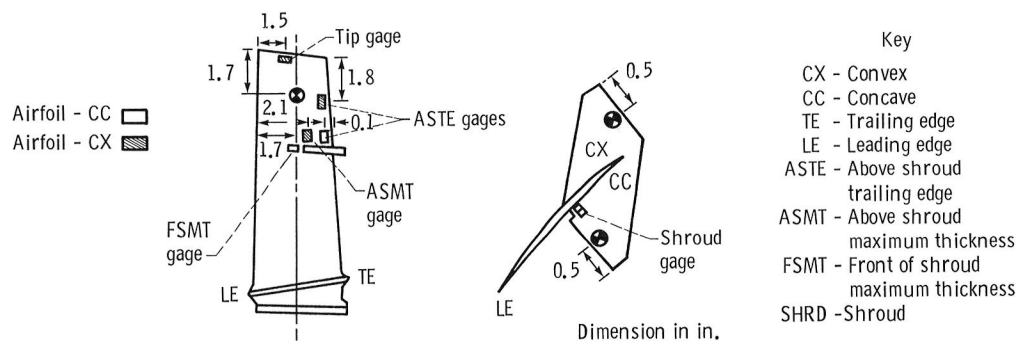
(a) First stage rotor.

Gage Location	Strain gage number																												Total
LE TIP-CX	1	2			3	4			5	6			7	8															8
TE TIP-CX	9	10							11	12																			4
ASTE-CC	13	14	15	16	17	18	19	20	21	22	23	24	25	26	27	28													16
ASMT-CX			29	30			31	32			33	34			35	36													8
FSMT-CC			37	38				39			40	41				42													6
SHRD-CC	43	44			45	46			47	48			49	50															8
																													50
